El Cajon Boulevard Median # M-27 [Cover Page & Summary]

This median strip is located on El Cajon Boulevard between: 43rd Street - and - Fairmount Avenue

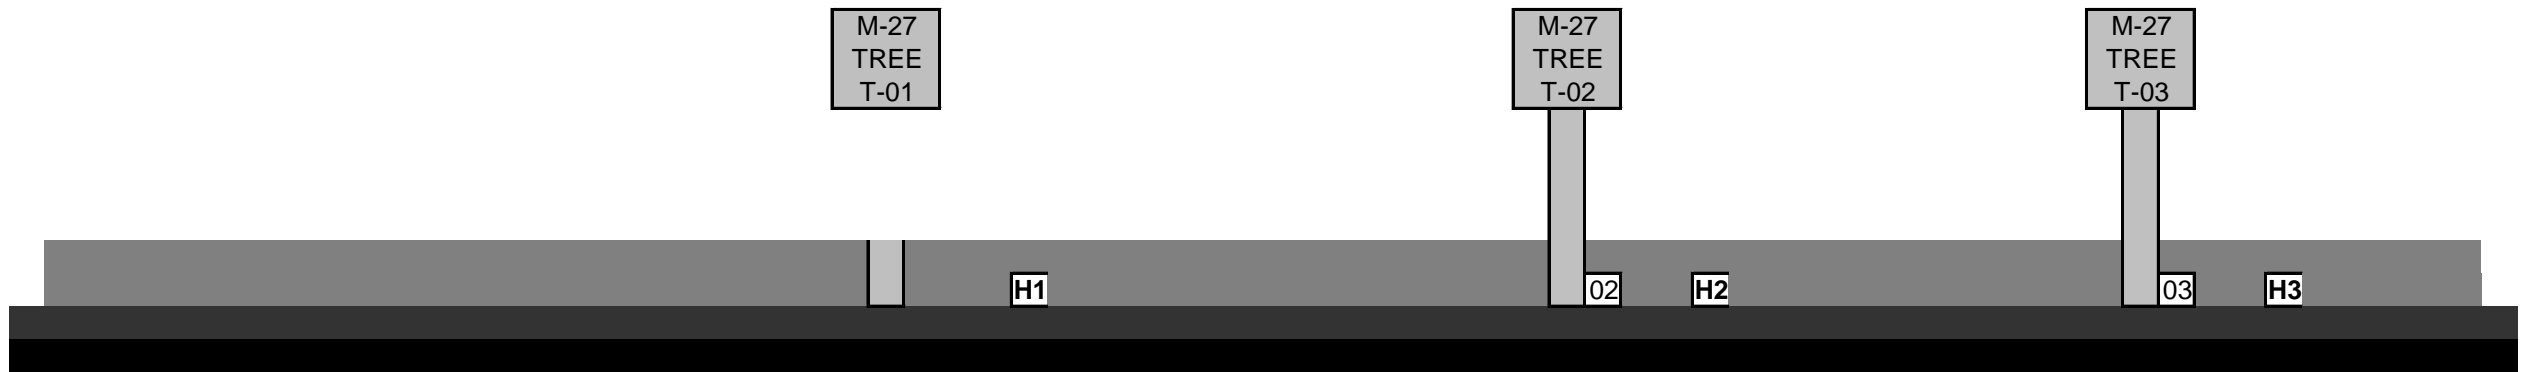
El Cajon Boulevard Median # M-27 Electrical Infrastructure Diagram for Decorative Lighting

Ln	Tree/Item	Description	Item Location	Condition	Lights*	Electrical Reference Value or Type	Feeder	Workable Parameter and Notes
1	T-01	Hole	All Missing					Never wired for LV
2	H1	High Voltage Box	10' E of T-01	Damaged		120V AC Duplex GFCI Outlet	Fed from middle of 4300 block of south side El Cajon Blvd	
3	T-02 & 02	Tree & Conduit	0.5' N of T-02	Damaged	None			Never wired for LV
4	H2	High Voltage Box	7.5' E of T-02	Damaged		120V AC Duplex GFCI Outlet	Fed from middle of 4300 block of south side El Cajon Blvd	
5	T-03 & 03	Tree - No Conduit or Wires	Conduit or Wires Missing		None			Never wired for LV
6	H3	High Voltage Box	11' E of T-03	Appears serviceable		120V AC Duplex GFCI Outlet	Fed from middle of 4300 block of south side El Cajon Blvd	
7								
8								
9								
10								
11								
12								
13								
14								
15								
16	Note: No low voltage of any kind							
17	* NL = strung with lights not lit; YL = strung with working lights; None = not strung with lights
