El Cajon Boulevard Median # M-28 [Cover Page & Summary]

This median strip is located on El Cajon Boulevard between: Fairmount Avenue - and - 44th Street (North Side)

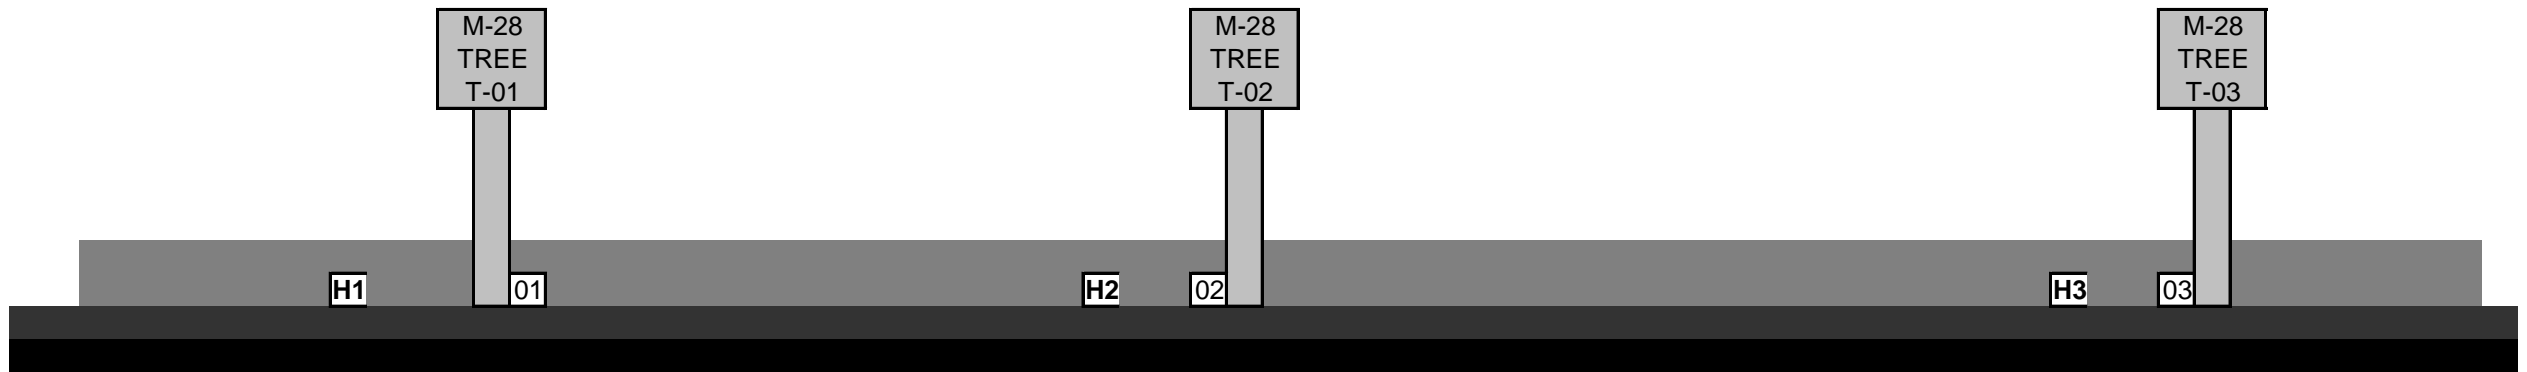
El Cajon Boulevard Median # M-28 Electrical Infrastructure Diagram for Decorative Lighting

| Ln | Tree/Item | Description | Item Location | Condition | Lights* | Electrical Reference Value or Type | Feeder | Workable Parameter and Notes |
|---|---|---|---|---|---|---|---|---|
| 1 | H1 | High Voltage Box | 8' W of T-01 | Damaged | | 120V AC Duplex GFCI Outlet | | Fed from middle of 4300 block of south side El Cajon Blvd |
| 2 | T-01 & 01 | Tree & Wires | 0.5' N of T-01 | Damaged | YL | Low Voltage Wires | | 12V operational |
| 3 | H2 | High Voltage Box | 9' W of T-02 | Damaged | | 120V AC Duplex GFCI Outlet | | Fed from middle of 4300 block of south side El Cajon Blvd |
| 4 | T-02 & 02 | Tree & Conduit | 0.5' NNW of T-02 | Damaged | NL | Low Voltage Wires | | High & low voltage appears to be sharing same conduit |
| 5 | H3 | High Voltage Box | 7' W of T-03 | Damaged | | 120V AC Duplex GFCI Outlet | | Fed from middle of 4300 block of south side El Cajon Blvd |
| 6 | T-03 & 03 | Tree & Conduit | 0.5' NNW of T-03 | Damaged | NL | Low Voltage Wires | | High & low voltage appears to be sharing same conduit |
