El Cajon Boulevard Median # M-29 [Cover Page & Summary]

This median strip is located on El Cajon Boulevard between: 44th Street (North Side) - and - 44th Street (South Side)

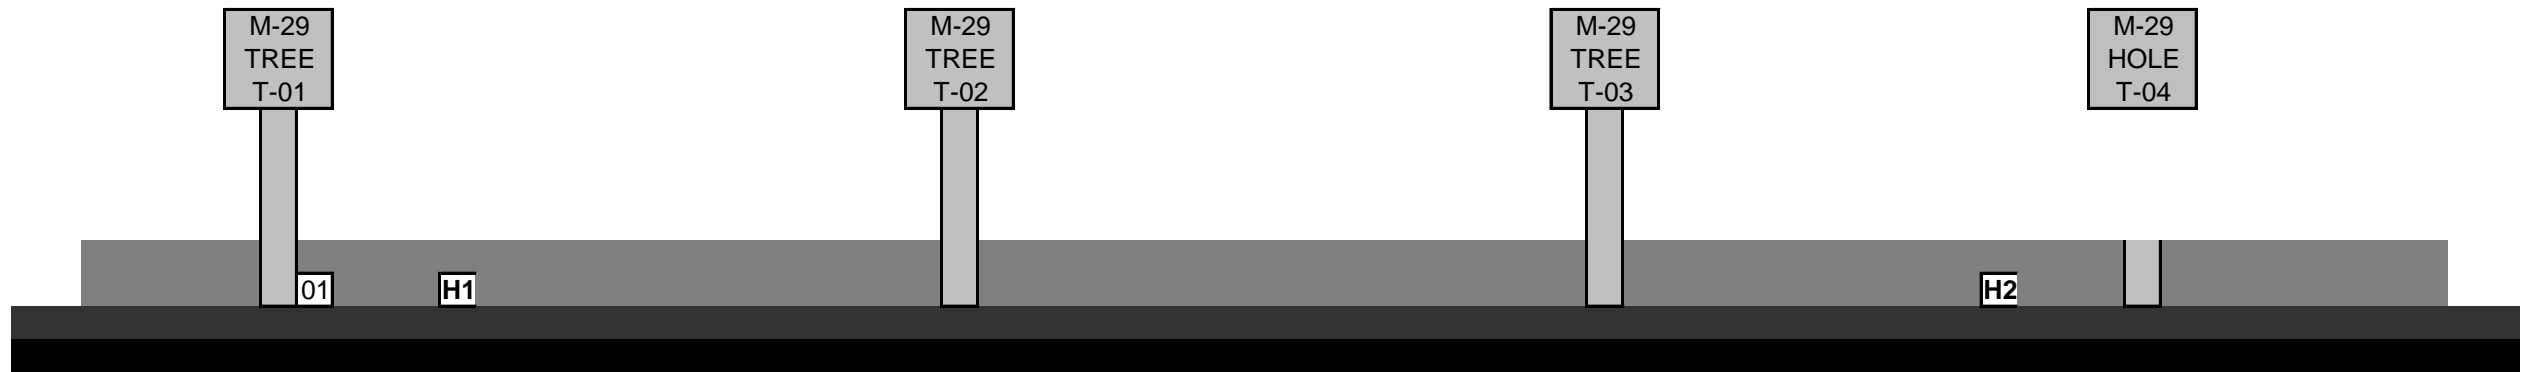
El Cajon Boulevard Median # M-29 Electrical Infrastructure Diagram for Decorative Lighting

Ln	Tree/Item	Description	Item Location	Condition	Lights*	Electrical Reference Value or Type	Feeder	Workable Parameter and Notes
1	T-01 & 01	Tree & Conduit	0.5' N of T-01	Damaged	NL	Low Voltage Wires	High & low voltage appears to be sharing same conduit	
2	H1	High Voltage Box	15' E of T-01	Appears serviceable		120V AC Duplex GFCI Outlet	Fed from middle of 4300 block of south side El Cajon Blvd	
3	T-02	Tree - No Conduit or Wires	Conduit or Wires Missing		NL			
4	T-03	Tree - No Conduit or Wires	Conduit or Wires Missing		NL			
5	H2	High Voltage Box	8' W of T-04	Damaged		120V AC Duplex GFCI Outlet	Fed from middle of 4300 block of south side El Cajon Blvd	
6	T-04	Hole	All Missing					
7								
8								
9								
10								
11								
12								
13								
14								
15								
16	Note: No low voltage of any kind							
17	* NL = strung with lights not lit; YL = strung with working lights; None = not strung with lights
