El Cajon Boulevard Median # M-27 [Cover Page & Summary]

This median strip is located on El Cajon Boulevard between: 43rd Street - and - Fairmount Avenue

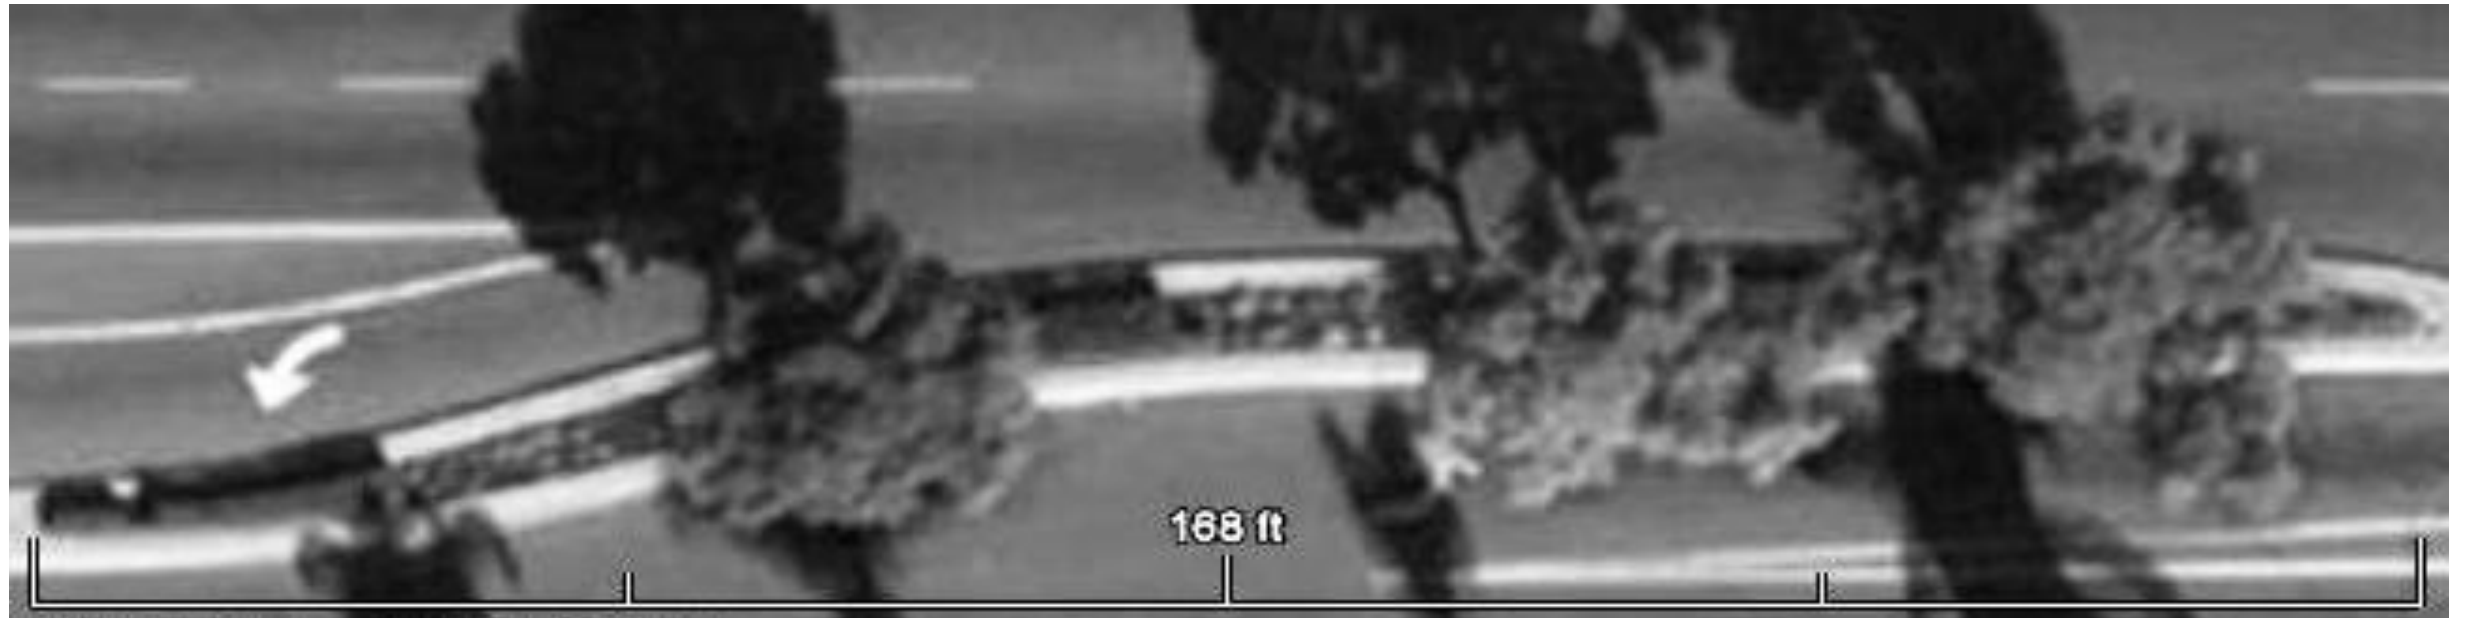
El Cajon Boulevard Median # M-27 [Top View - Planted Areas Only]

Three (3) tree spaces evenly spaced. One (1) tree missing.

Two (2) trees with no decorative lighting installed.

High voltage power supply working and controlled by off site control. Breakers located on south sidewalk at the middle of 4300 block of El Cajon Blvd.

No low voltage boxes or evidence of any low voltage system installed; 120V AC available on median.

All exposed wiring is showing signs of weathering and age as older plastics breakdown in sunlight.

Weed Eater damage is extensive - look for better future option that can take this type of normal wear and tear.

Ln	Tree/Item	Description	Item Location	Condition	Lights*	Electrical Reference Value or Type	Feeder	Workable Parameter and Notes
1	T-01	Hole	All Missing					Never wired for LV
2	H1	High Voltage Box	10' E of T-01	Damaged		120V AC Duplex GFCI Outlet	Fed from middle of 4300 block of south side El Cajon Blvd	
3	T-02 & 02	Tree & Conduit	0.5' N of T-02	Damaged	None			Never wired for LV
4	H2	High Voltage Box	7.5' E of T-02	Damaged		120V AC Duplex GFCI Outlet	Fed from middle of 4300 block of south side El Cajon Blvd	
5	T-03 & 03	Tree - No Conduit or Wires	Conduit or Wires Missing		None			Never wired for LV
6	H3	High Voltage Box	11' E of T-03	Appears serviceable		120V AC Duplex GFCI Outlet	Fed from middle of 4300 block of south side El Cajon Blvd	
7								
8								
9								
10								
11								
12								
13								
14								
15								
16	Note: No low voltage of any kind							
17	* NL = strung with lights not lit; YL = strung with working lights; None = not strung with lights
