El Cajon Boulevard Median # M-28 [Cover Page & Summary]

This median strip is located on El Cajon Boulevard between: Fairmount Avenue - and - 44th Street (North Side)

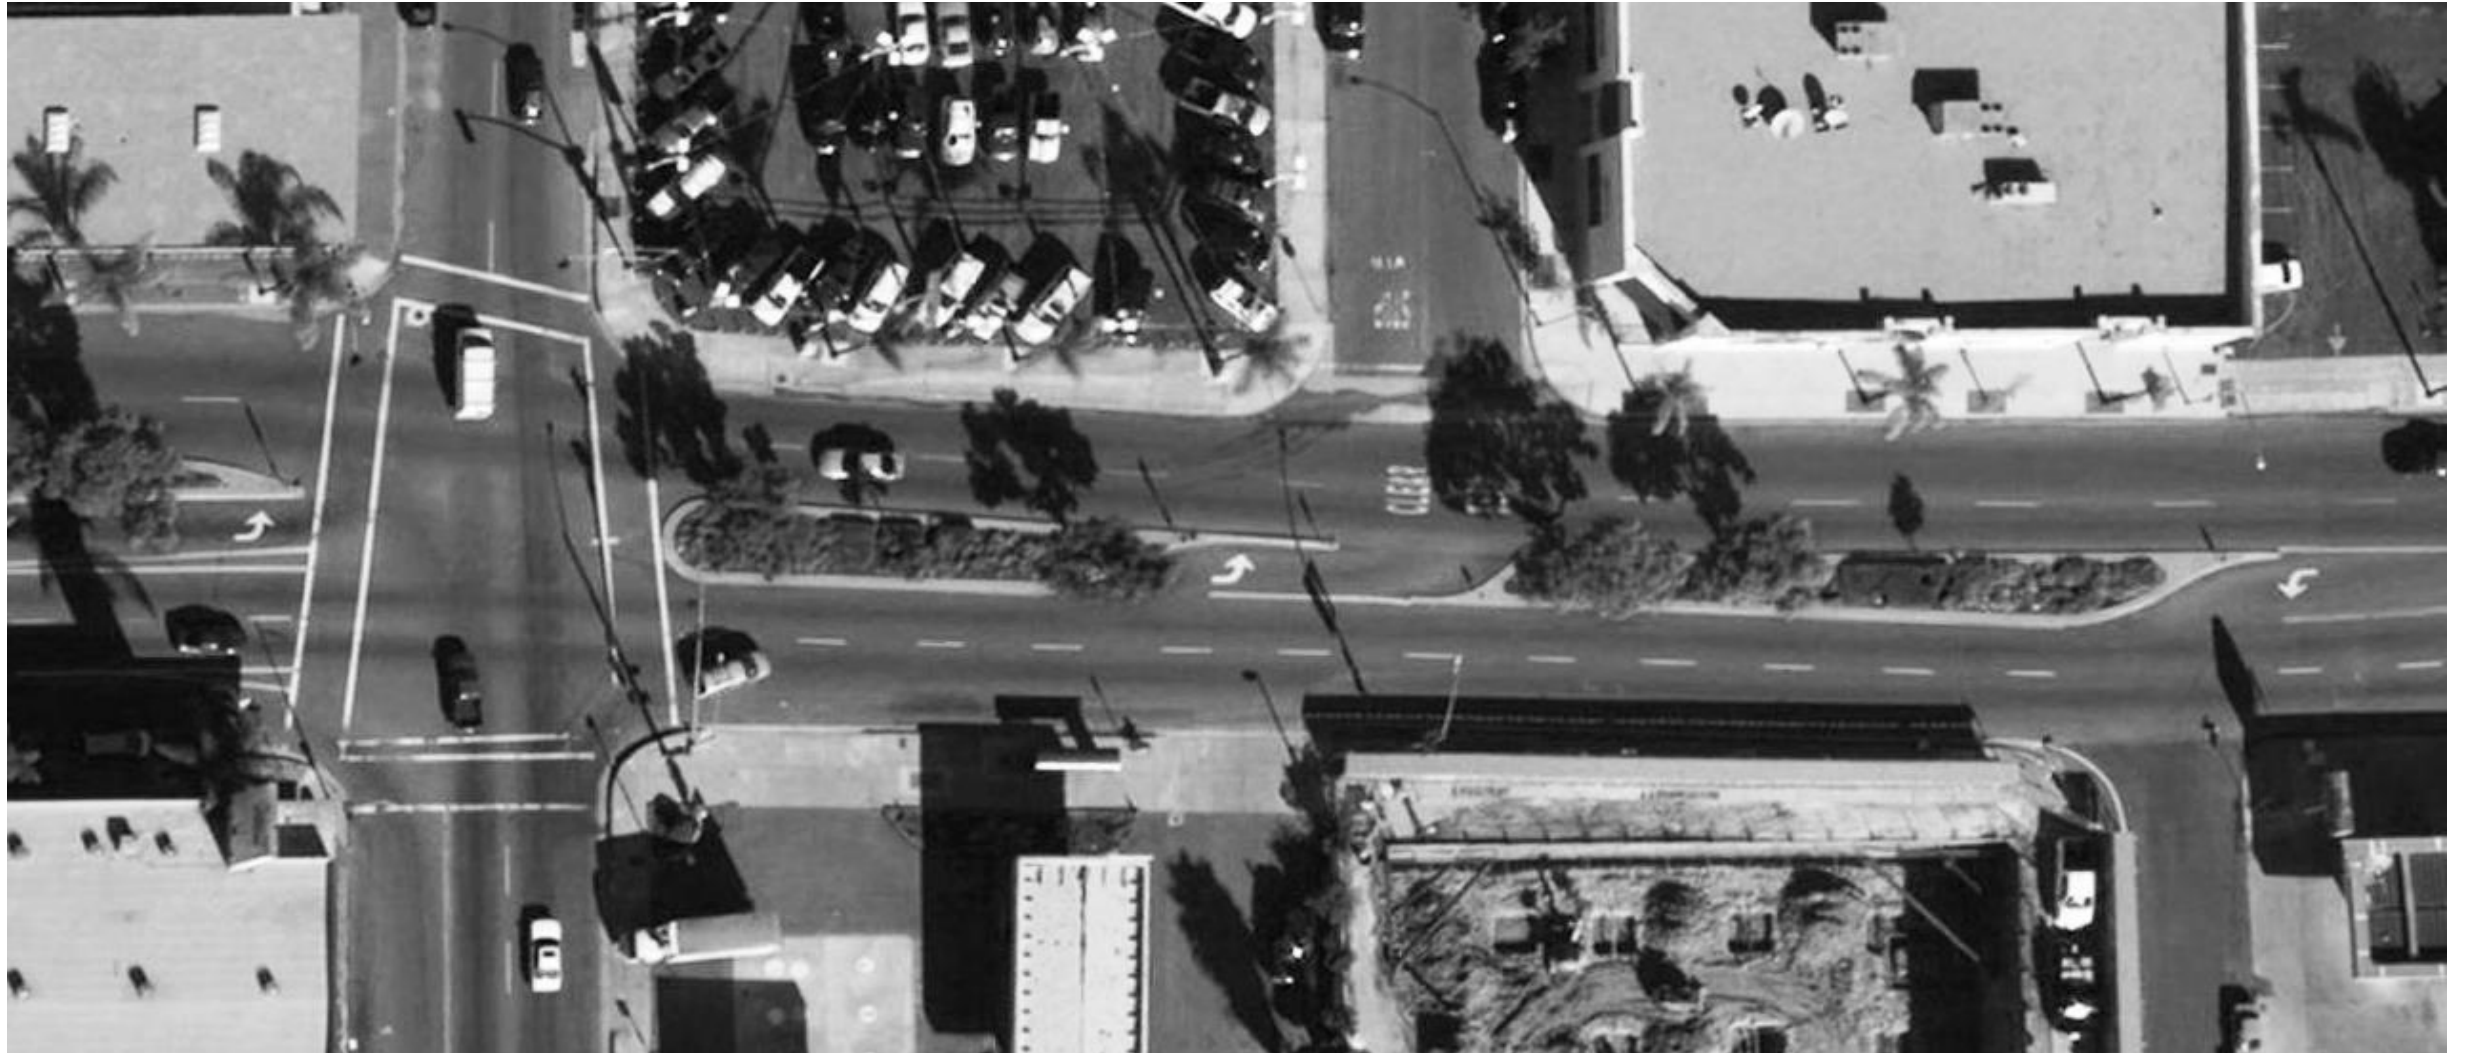
Three (3) tree spaces evenly spaced. No trees missing.

One (1) tree with old incandescent decorative lighting installed and working.

All exposed wiring is showing signs of weathering and age as older plastics breakdown in sunlight.

Weed Eater damage is extensive - look for better future option that can take this type of normal wear and tear.

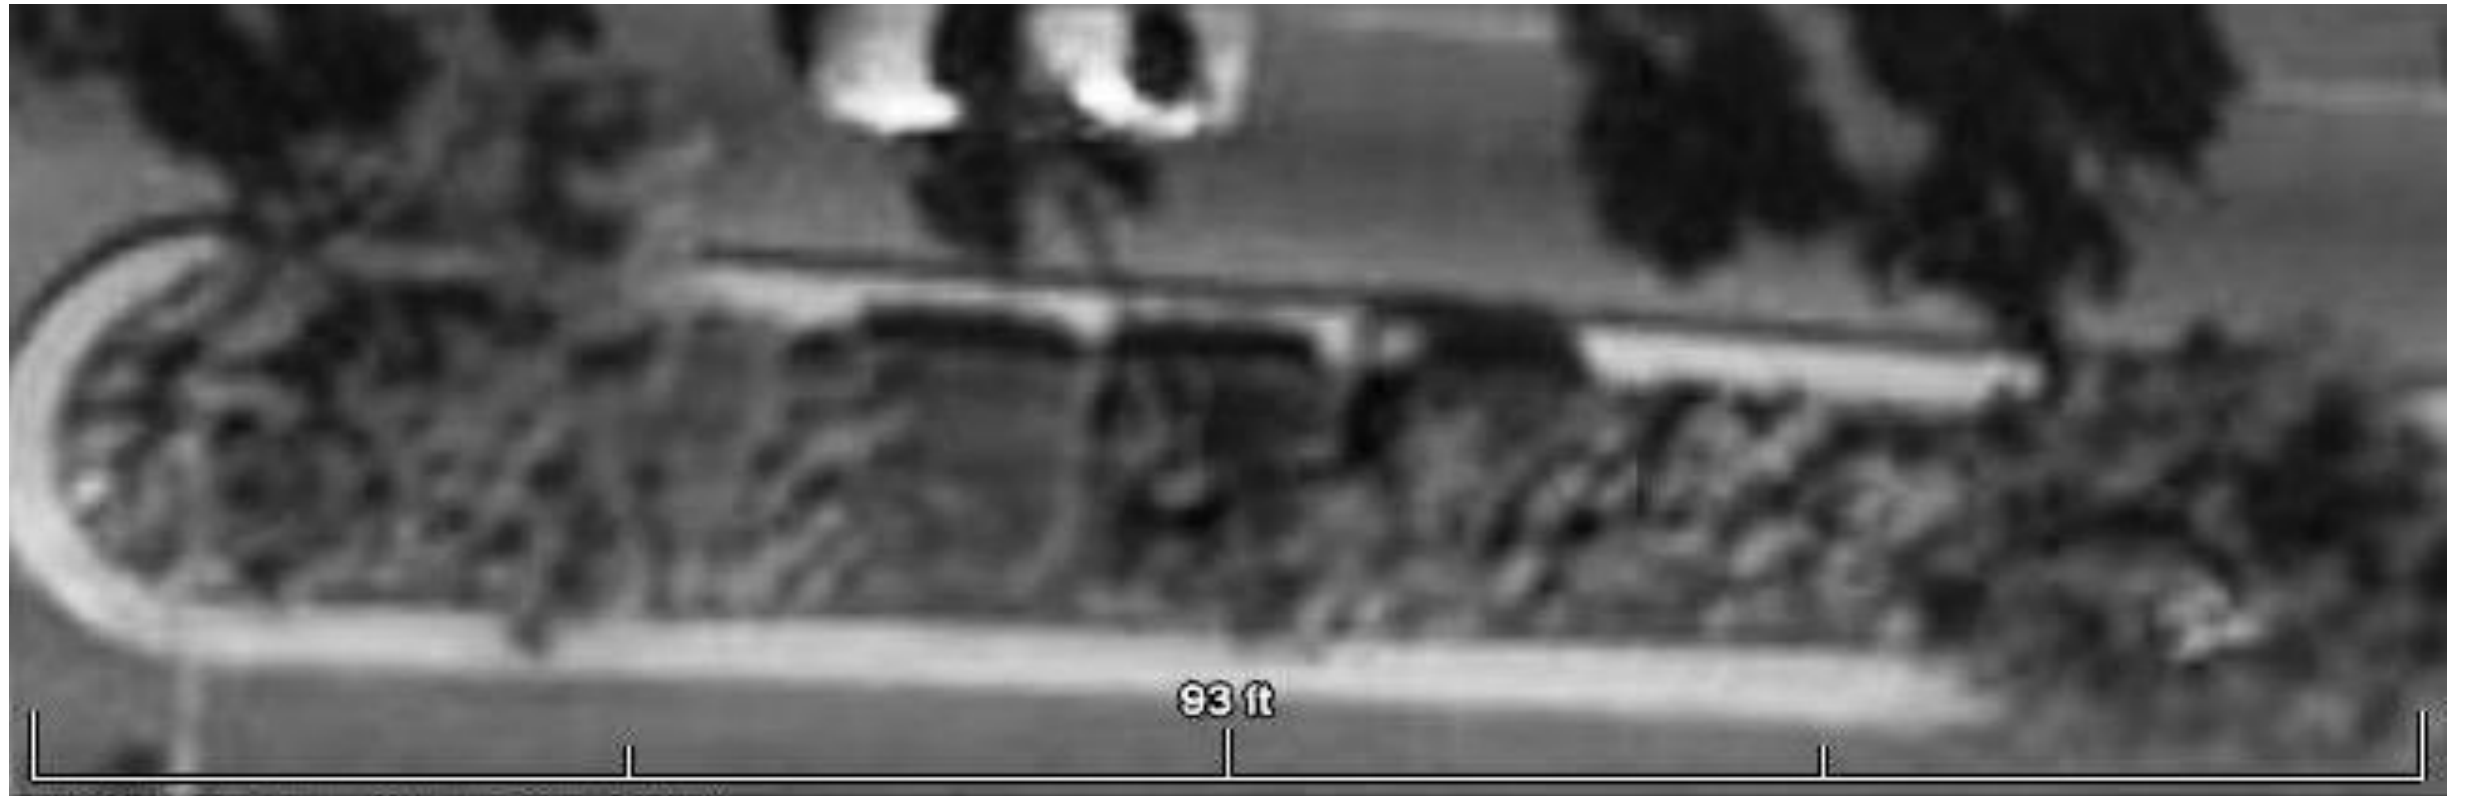
El Cajon Boulevard Median # M-28 [Top View - Planted Areas Only]

| Ln | Tree/Item | Description | Item Location | Condition | Lights* | Electrical Reference Value or Type | Feeder | Workable Parameter and Notes |
|---|---|---|---|---|---|---|---|---|
| 1 | H1 | High Voltage Box | 8' W of T-01 | Damaged | | 120V AC Duplex GFCI Outlet | | Fed from middle of 4300 block of south side El Cajon Blvd |
| 2 | T-01 & 01 | Tree & Wires | 0.5' N of T-01 | Damaged | YL | Low Voltage Wires | | 12V operational |
| 3 | H2 | High Voltage Box | 9' W of T-02 | Damaged | | 120V AC Duplex GFCI Outlet | | Fed from middle of 4300 block of south side El Cajon Blvd |
| 4 | T-02 & 02 | Tree & Conduit | 0.5' NNW of T-02 | Damaged | NL | Low Voltage Wires | | High & low voltage appears to be sharing same conduit |
| 5 | H3 | High Voltage Box | 7' W of T-03 | Damaged | | 120V AC Duplex GFCI Outlet | | Fed from middle of 4300 block of south side El Cajon Blvd |
| 6 | T-03 & 03 | Tree & Conduit | 0.5' NNW of T-03 | Damaged | NL | Low Voltage Wires | | High & low voltage appears to be sharing same conduit |
