El Cajon Boulevard Median # M-23 [Cover Page & Summary]

This median strip is located on El Cajon Boulevard between: 38th Street - and - 40th Street / I-15 Intersection

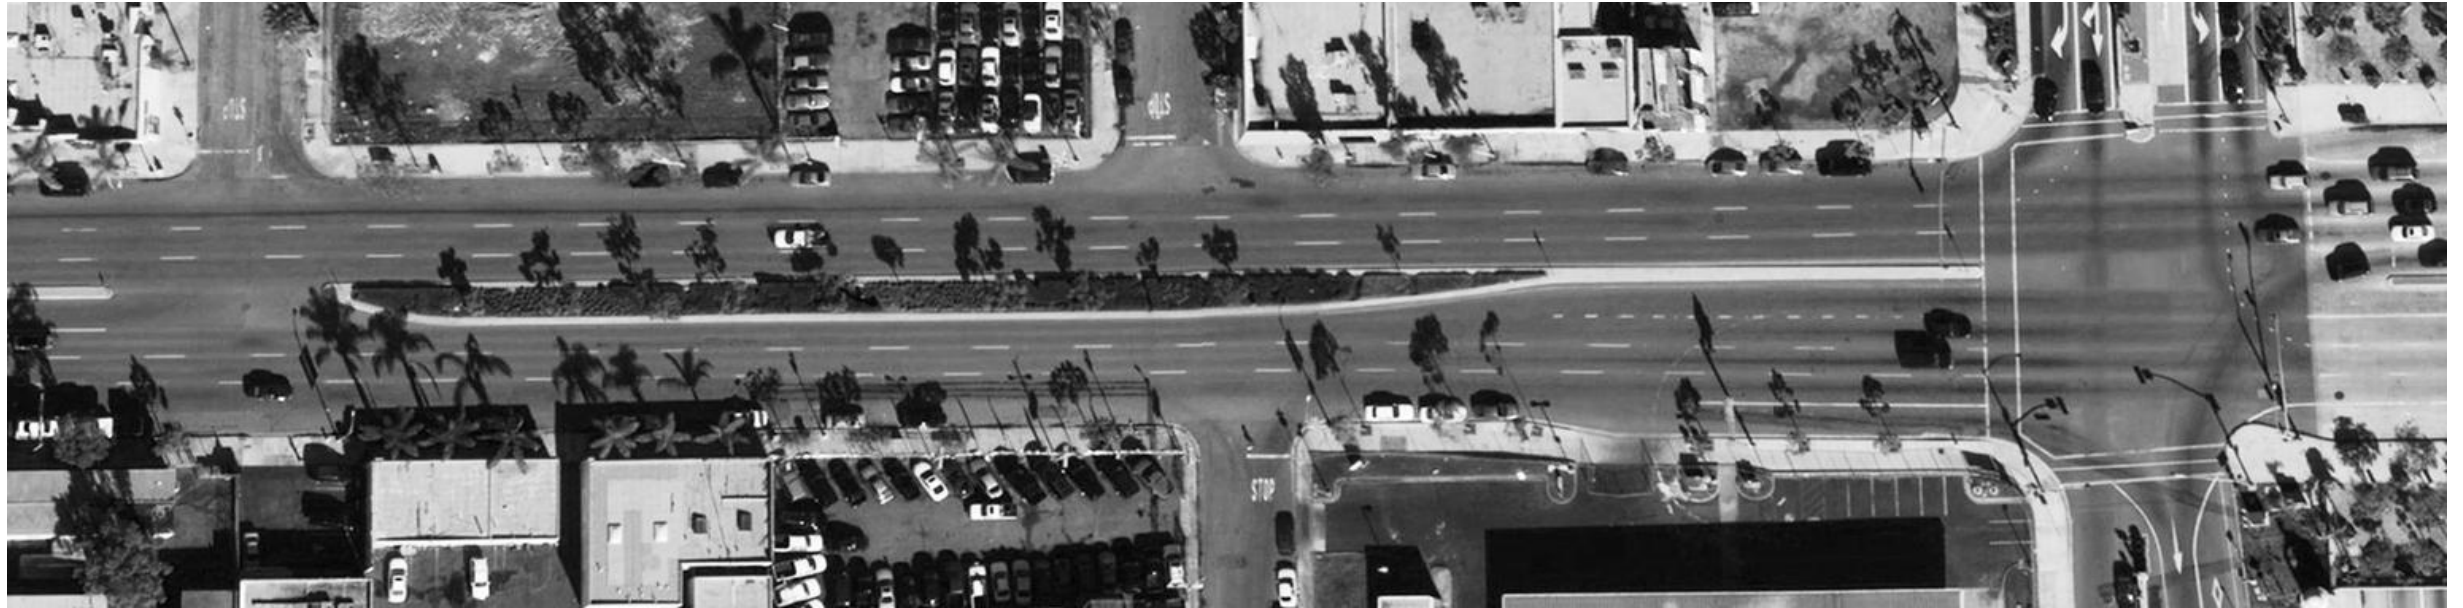
El Cajon Boulevard Median # M-23 Electrical Infrastructure Diagram for Decorative Lighting

< West [Side View facing North - Planted Areas Only] East >

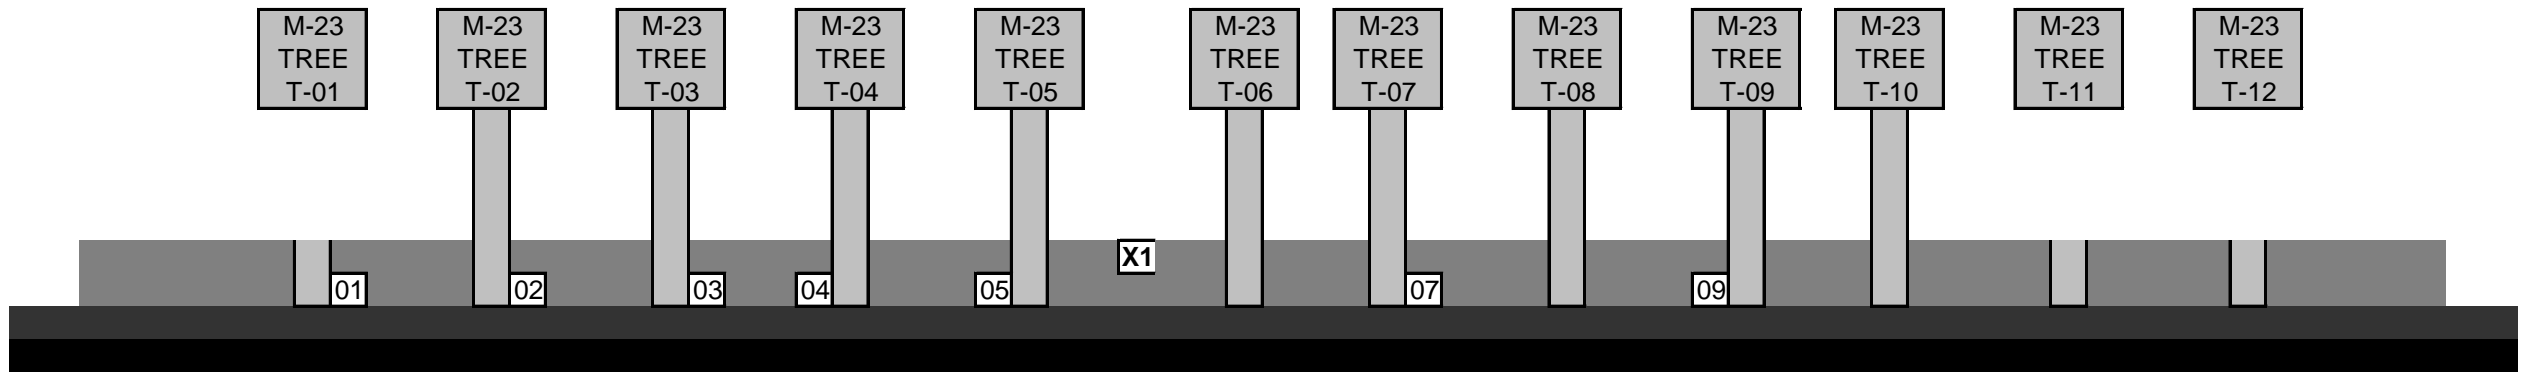
Twelve (12) tree spaces evenly spaced. Three (3) trees missing.

Seven (7) trees with old incandescent decorative lighting installed and not working.

Most low voltage connection boxes at tree bases visually appear serviceable with minimum repairs.

The "pig tails" to ALL trees need upgrading for operation and safety reasons. All exposed wiring is showing signs of weathering and age as older plastics breakdown in sunlight.

Weed Eater damage is extensive - look for better future option that can take this type of normal wear and tear.

Low voltage transformer located in a large above ground stainless steel metal box with ample workspace in good condition, rated at 120V, 1.5kVA, secondary 300W - load circuits undetermined.
